AGENDA
Planning Commission Meeting
June 23, 2026 @ 5:30 PM

1. Major Subdivision, Sketch Plan Review, Pagosa West

Arena Labs LLC has applied for the Approval of Pagosa West Major **Subdivision, Amendment 2025-01, Sketch Plan at 80 S. Pagosa Blvd, 100 S. Pagosa Blvd, and 3800 W. Hwy 160 (Parcel #s 569920156001, 569921229001, 569920400163)**. The applicant plans to develop the entire site to accommodate residential, mixed-use commercial, and open space to better serve the entire community. The existing parcels are zoned Mixed-Use Corridor (MU-C), Mixed-Use Town Center (MU-TC), and Mixed-Use Residential (MU-R).

PAGOSA WEST
 PAGOSA SPRINGS, CO
 CONCEPT DEVELOPMENT PLAN
 04.22.2026

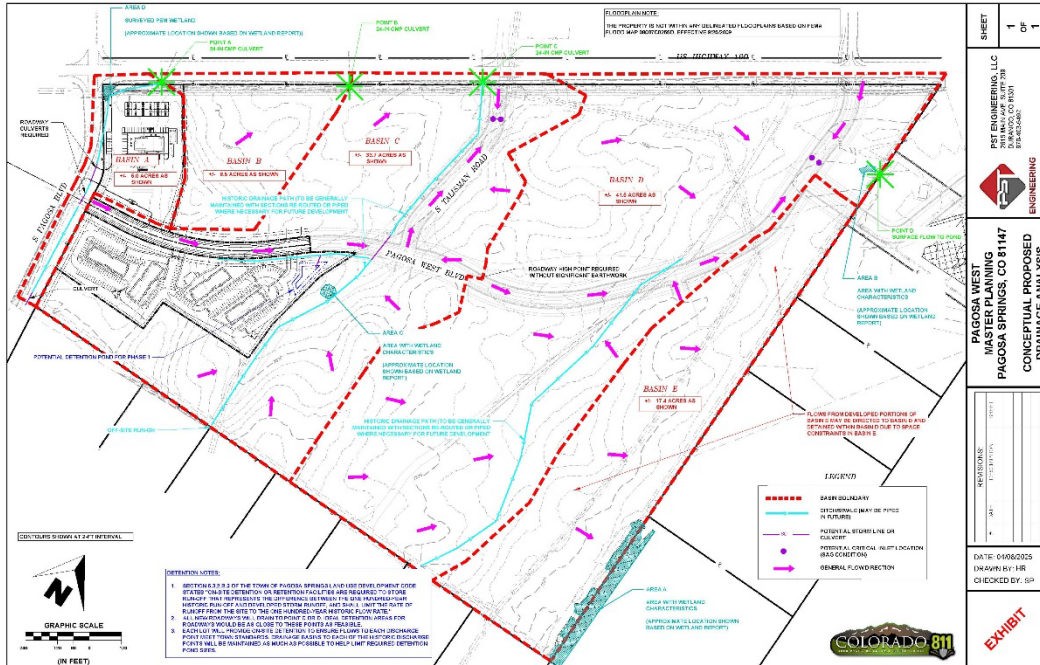
Figure 3: Conceptual Drainage

impacting surrounding areas. For the submission of the Preliminary Plan Review, a drainage study, prepared by a Licensed Professional Colorado Engineer will be required. Stormwater detention is required to be depicted at Preliminary Application for all roads, sidewalks and trails.

3. Applicant must set and depict reference monuments for all perimeter boundaries within the proposed major subdivision development (LUDC 7.3.9).
4. Applicant must submit a Drainage Study, prepared by a Licensed Colorado Professional Engineer, with runoff rates determined using the NRCS TR-20 method, to include detention for all roads, sidewalks, and trails. This study must also identify the current condition of the drainage culverts that would divert water under Highway 160 (LUDC 6.3.2)

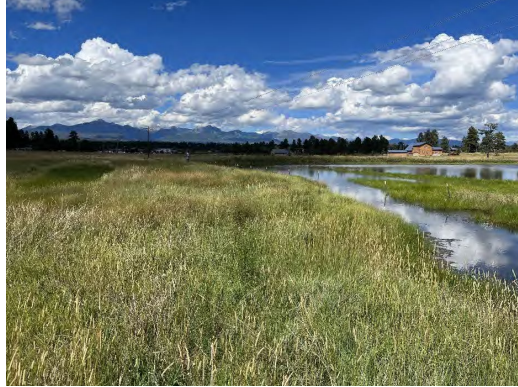
Figure 4: View of Wetland Area Looking North

Though the State of Colorado has not yet developed final rules as a result of HB24-1379, verification shall be provided by the Colorado Department of Public Health and Environment regarding the need for a Temporary Authorization for fill not subject to federal jurisdiction, as well as any Clean Water Act permitting that may be required. Avoidance and protection of identified wetlands shall be addressed in the Preliminary Subdivision application. Additional U.S. Army Corps of Engineers permitting maybe required depending on totality of any impacts.

In addition to the wetlands delineation, the applicant adjusted the location and size of the multi-family development anticipated for Phase 1 to create a larger buffer from the Single-Family Residential Units to the south. By doing this, the developer allocated more open space for the development. The road networks were also reshaped to preserve mature Ponderosa Pine outcroppings and natural drainage areas.

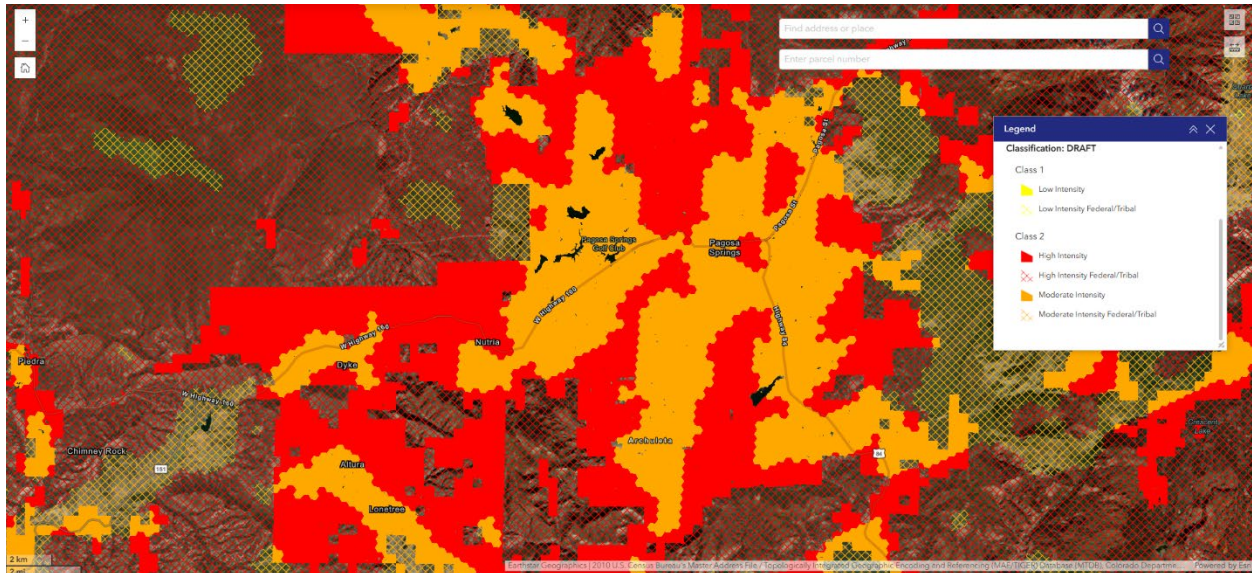
Figure 6: CWRC Hazard Map

This proposal, and the entirety of the Town of Pagosa Springs, is within Class 2 (Moderate and High Intensity) fire danger. This designation comes from the Colorado Wildfire Resiliency Code Board. With the adoption of the code by April 1, 2026, the developer will be required to comply with all provisions of LUDC Section 6.4.6 and the Wildfire Resiliency Code presented by the State of Colorado. This will be a review criteria for the proposed Multi-Family and Gasoline Sales Developments that are intended in Phase 1.

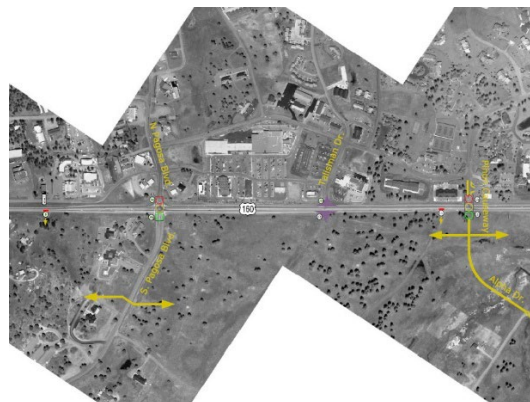
Figure 7: ACP

- i. New southern leg to be installed at the Pinon Causeway intersection traffic signal, consistent with the Access Control Plan.
- ii. New Right-in right-out only intersection at Talisman Drive, consistent with Access Control Plan.
- iii. Provide a plat dedication of a reserved area at SE corner of Hwy 160 and S. Pagosa to accommodate future HWY 160 225' diameter Traffic Circle and 40-foot setback.
- iv. Traffic Study Report is in process. A CDOT Access permit is required and will provide further considerations for access that should be included in the Preliminary Subdivision application.
- v. Staff has requested that the access for the Fuel C-Store lot be provided from the new internal road system, not from S. Pagosa Blvd, due to the volume of traffic expected for the proposed fuel station and the distance from the Hwy 160 intersection.

Internal Roadway design will be a function of the results of the Traffic Study. The main roadway, Pagosa West Drive, between S. Pagosa and Pinon Causeway will serve as a portion of the local road network contemplated in the Access Control Plan adopted by CDOT, Town and County. It is expected the Internal main road will be designed as a Major Collector Street serving more than 2,000 average daily vehicle trips and will separate the residential uses from the commercial uses. Accommodation for left-hand turn pockets should be considered for free-flowing traffic. Additionally, the development of internal roads will be phased out and detailed in their Development Improvement Agreement, that will be negotiated at the Preliminary Plan Review and executed at the Final subdivision application stage. The construction of internal roadways will be inspected by a qualified engineer and by the Town of Pagosa Springs Public Works Department. The newly developed roadways are intended to be adopted as publicly maintained roads by the Town of Pagosa Springs. The proposed subdivision's access points align with the jointly adopted Access Control Plan for US Hwy 160.

Access Control Plan (ACP): The concept sketch plan appears to be consistent with the intent of the adopted ACP regarding the Talisman Drive and Pinion Causeway Hwy 160 intersection improvements and the new internal connector roadway (Pagosa West Blvd).

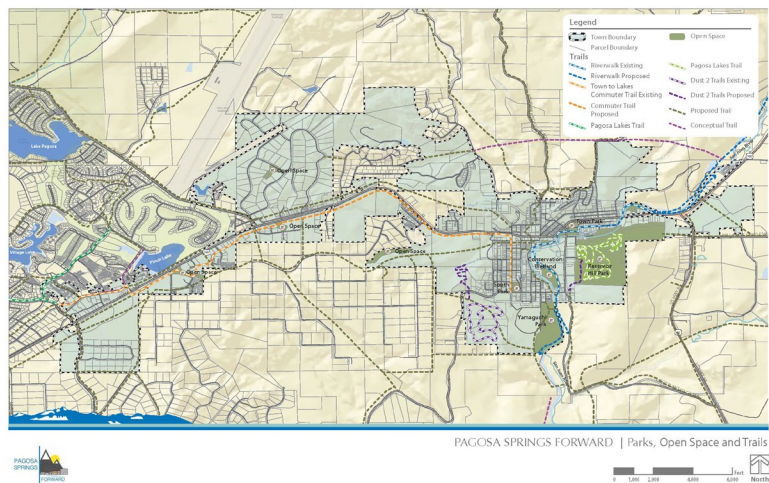
Figure 8: Proposed Trail Networks

This proposal addresses both of these action items by establishing housing and trails that are near intermodal transportation, trails, and employment. Some of the largest employers in our community (Pagosa Springs Medical Center, City Market, and Walmart) are within walking distance to the proposed multi-family development. Additionally, the developer aims to provide connection to the Town to Lakes Trail Master Plan with their proposed pedestrian network. The developer has also identified areas within their development for transit stops that would provide downtown connection to residents.

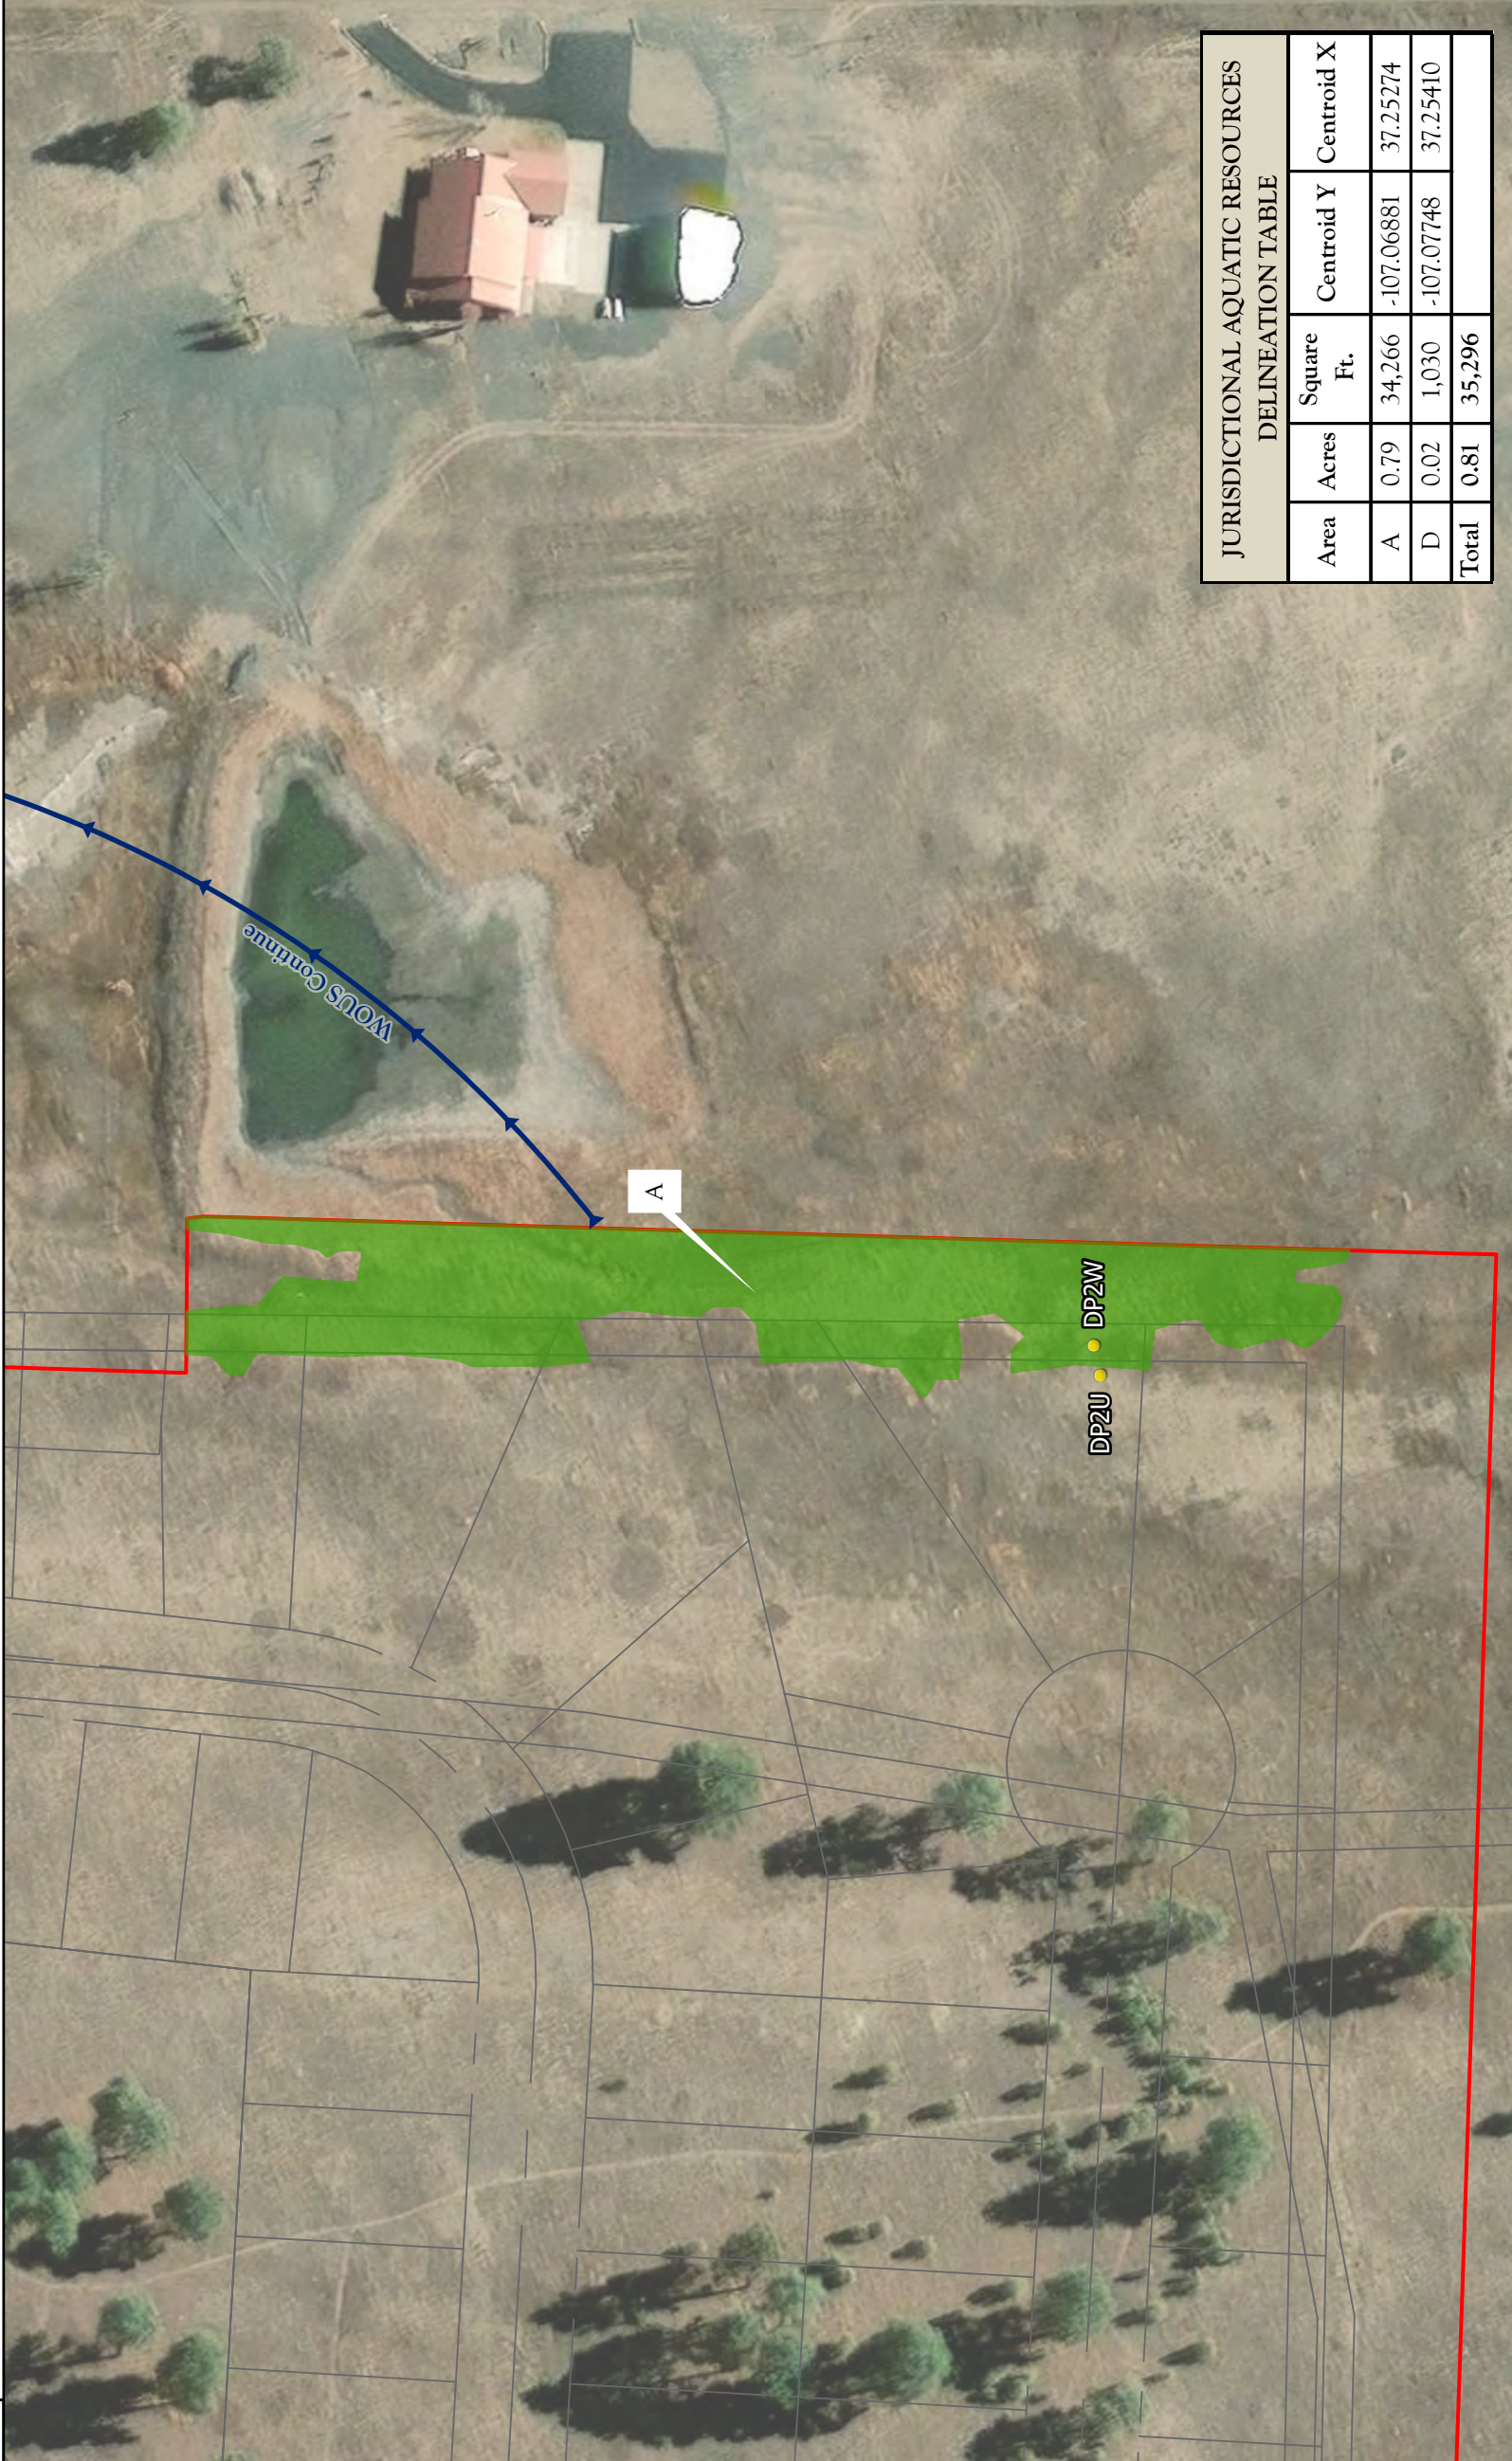
JURISDICTIONAL AQUATIC RESOURCES DELINEATION TABLE				
Area	Acres	Square Ft.	Centroid Y	Centroid X
A	0.79	34,266	-107.06881	37.25274
D	0.02	1,030	-107.07748	37.25410
Total	0.81	35,296

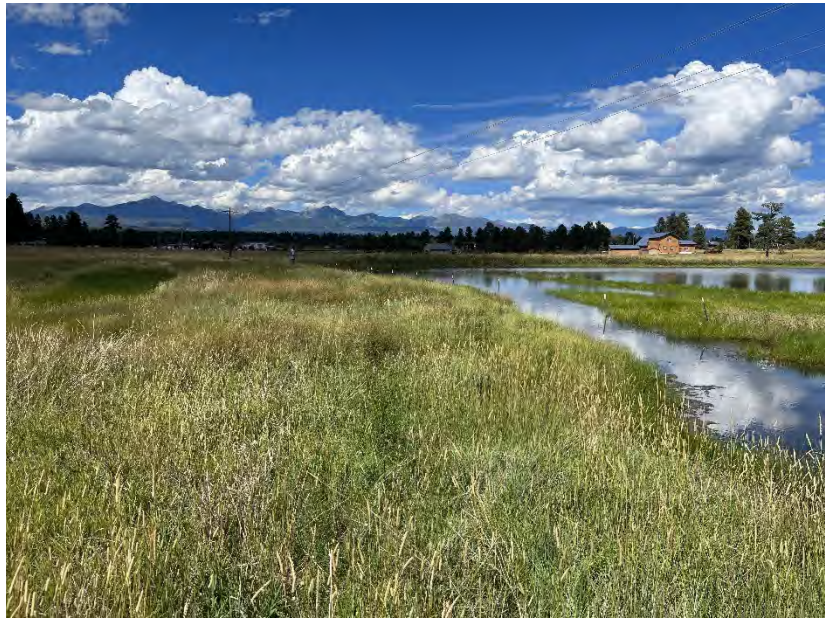
Photo 1: View of wetland area A looking north.

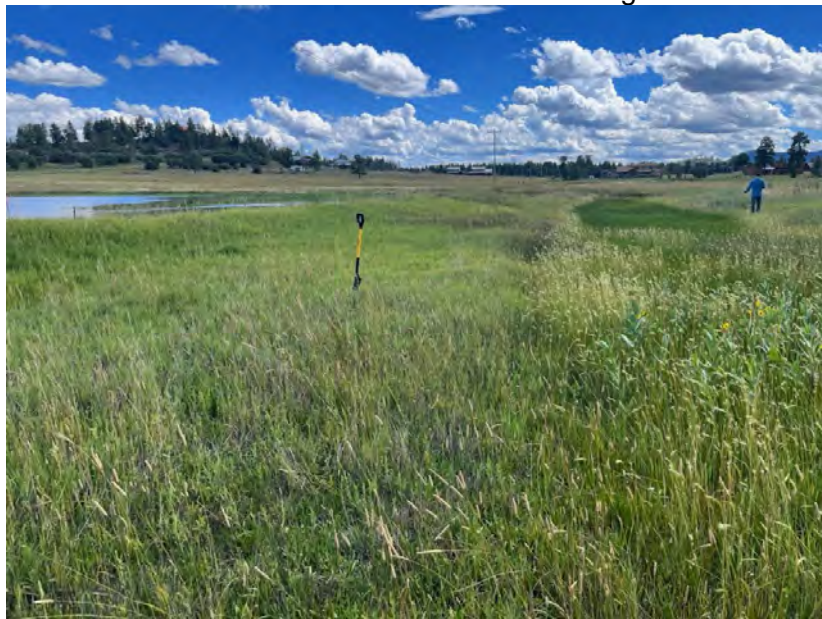
Photo 2: View of wetland area A looking south.

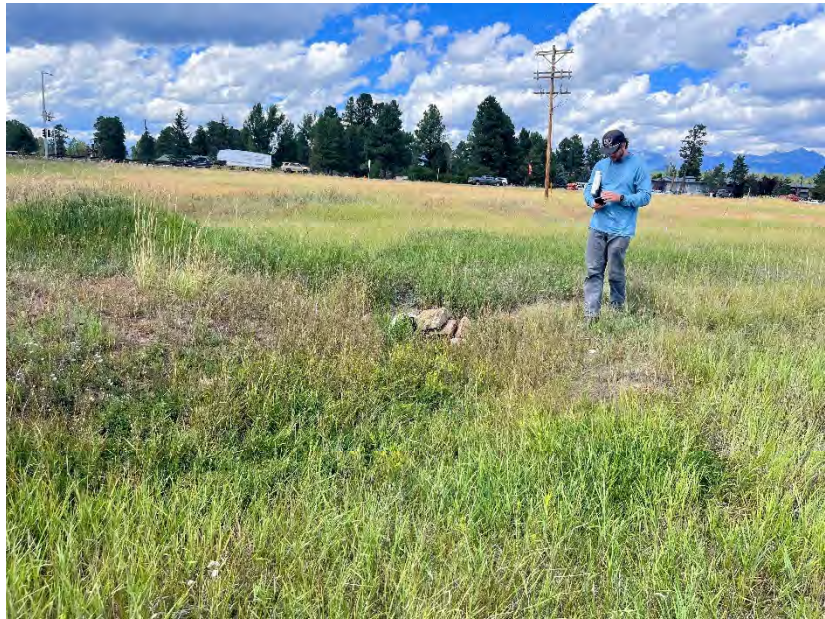
Photo 10: View of culvert northeast of Area B.

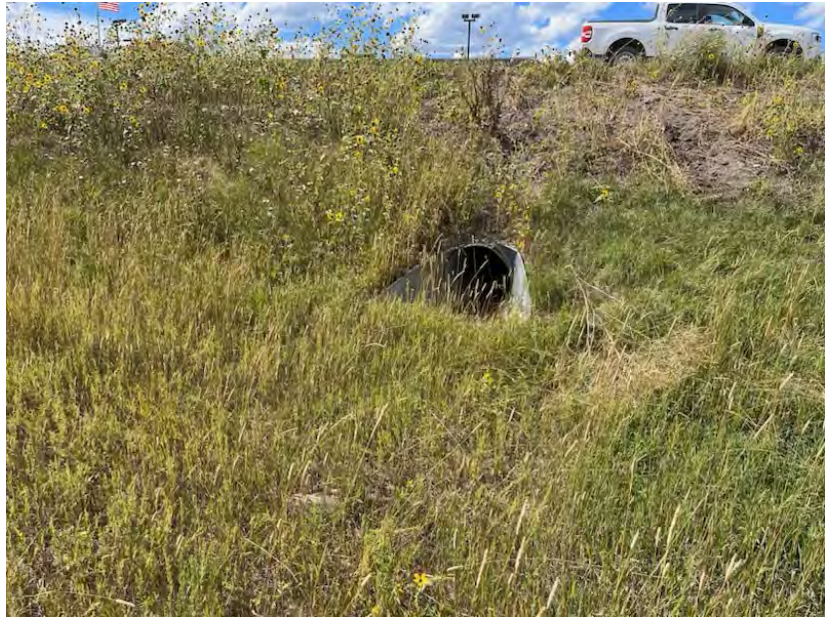
Photo 15: View of culvert on north end of Area C.

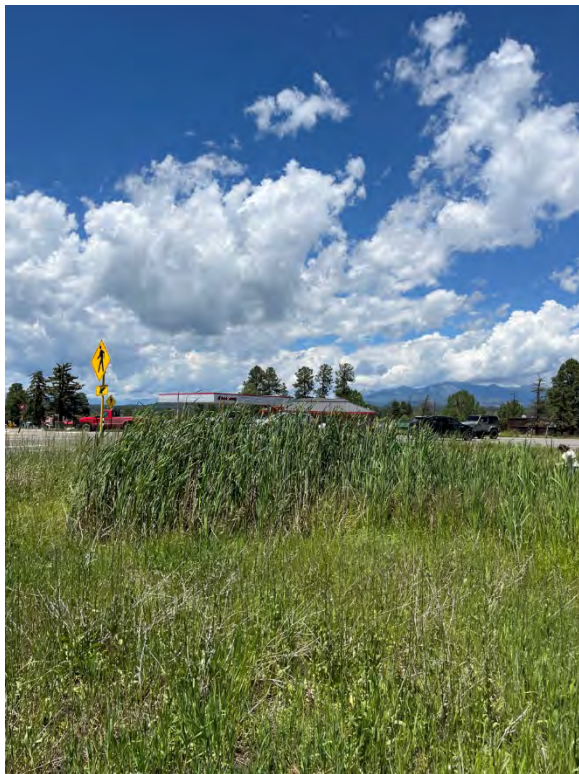
Photo 18: View of wetland area D.

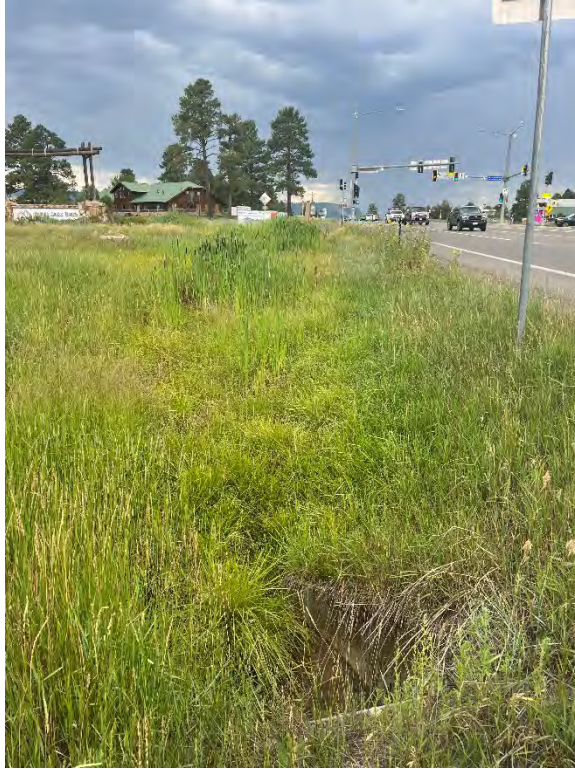
Photo 19: View of wetland area that connects to wetland area D from culvert.

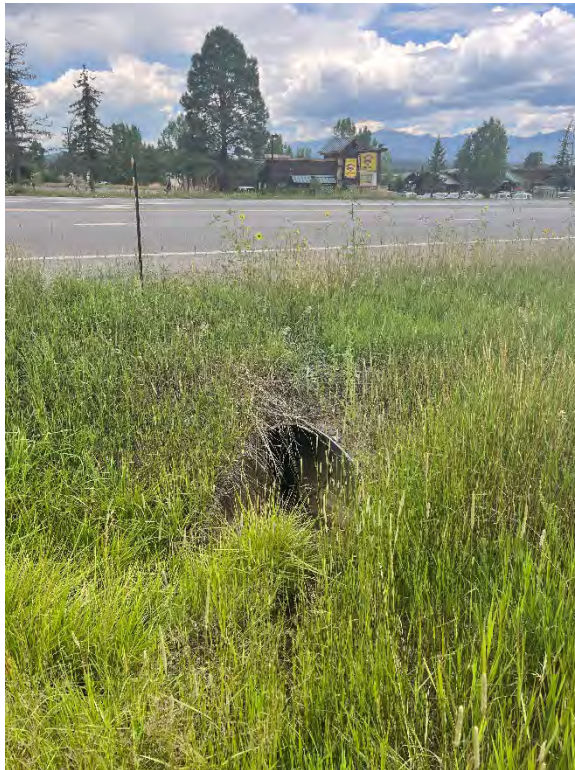
Photo 20: Culvert that drains wetland area D.
